مشروع قناطر نجع حمادى الجديدة

التسرب بعد الغمر في مشروع قناطر نجع حمادى الجديدة

(Leakage after Impounding for New Naga Hamadi Barrage Project)

Leakage Report

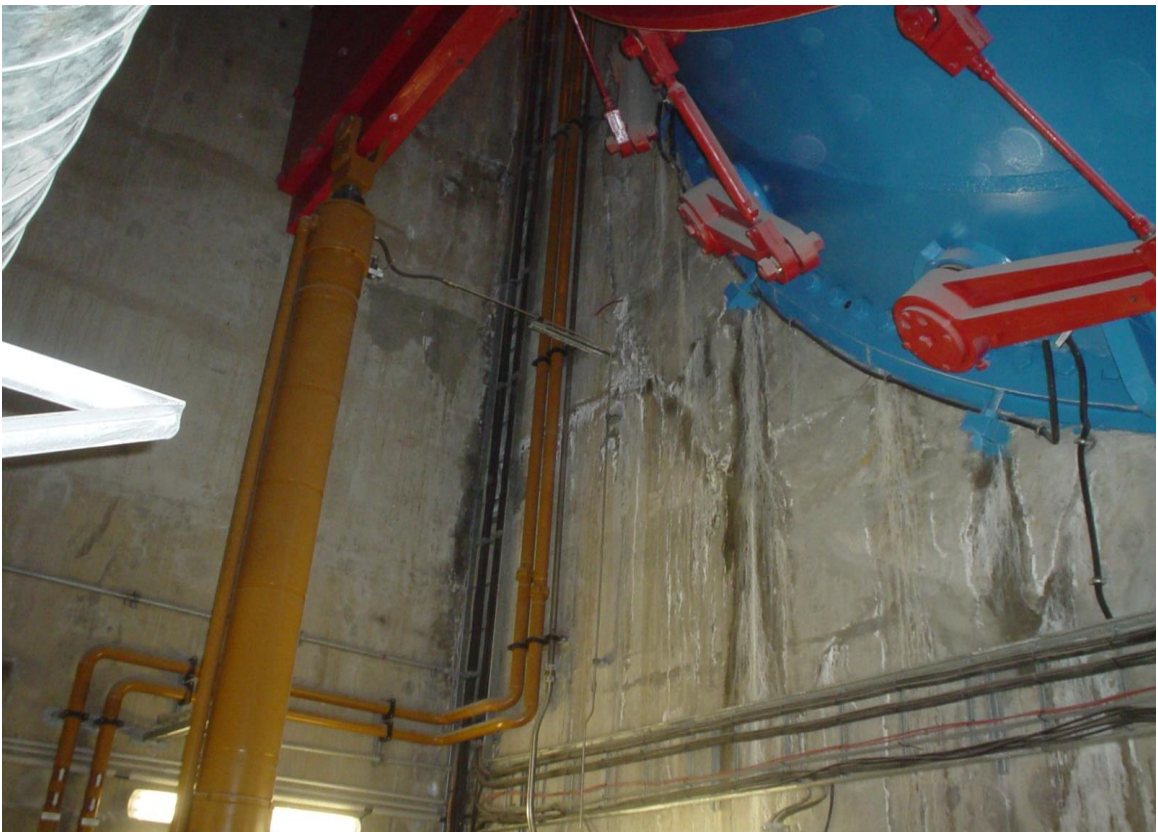
Picture 14: Leakage (1*) at d/s wall corners, between El. 51.10 & 43.20, encountered at all Units.

1* At the d/s wall corners between El. 51.10 & 43.20.

3* Third stage concrete joints around the distributor anchor ring.

The observed leakage quantities at the Wicket Gate Rooms are insignificant. Most of the actual leakage amount evaporates without reaching the gutter or the floor level.

As documented by the above findings, the observed leakage quantities are insignificant and no injection works are required. It is expected that current leakage rates will further reduce due to the following: a) the self-healing process, even if slowed down, will continue, and b) by the ventilation system in operation remaining wet spots will dry out.
